City of Detroit
Department of Recreation Performance Audit
Exhibit 1 – Belle Isle

Casino

Overall Evaluation – Fair Condition

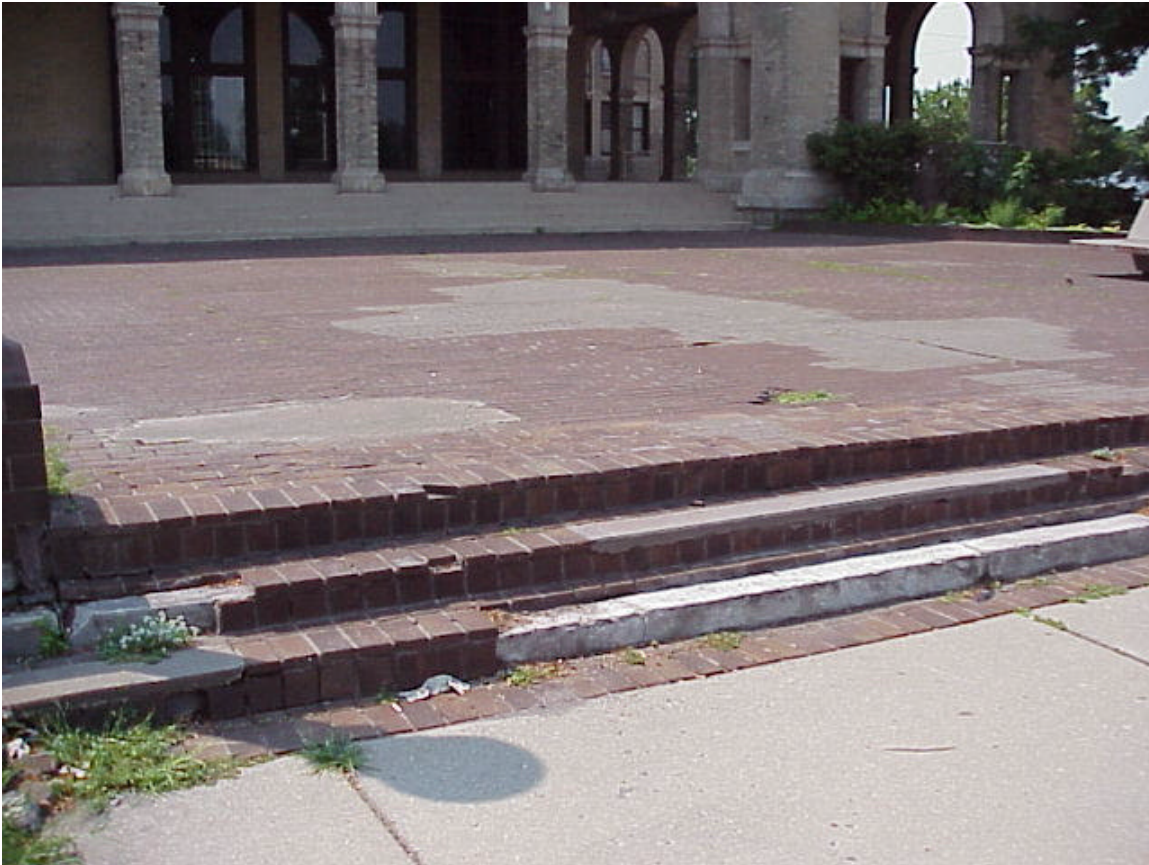
- Crumbling outside stairs.
- Cracks in the walkway leading to the entrance.
- Aesthetically appealing interior.

The stairs and patio area leading into the casino were crumbling.

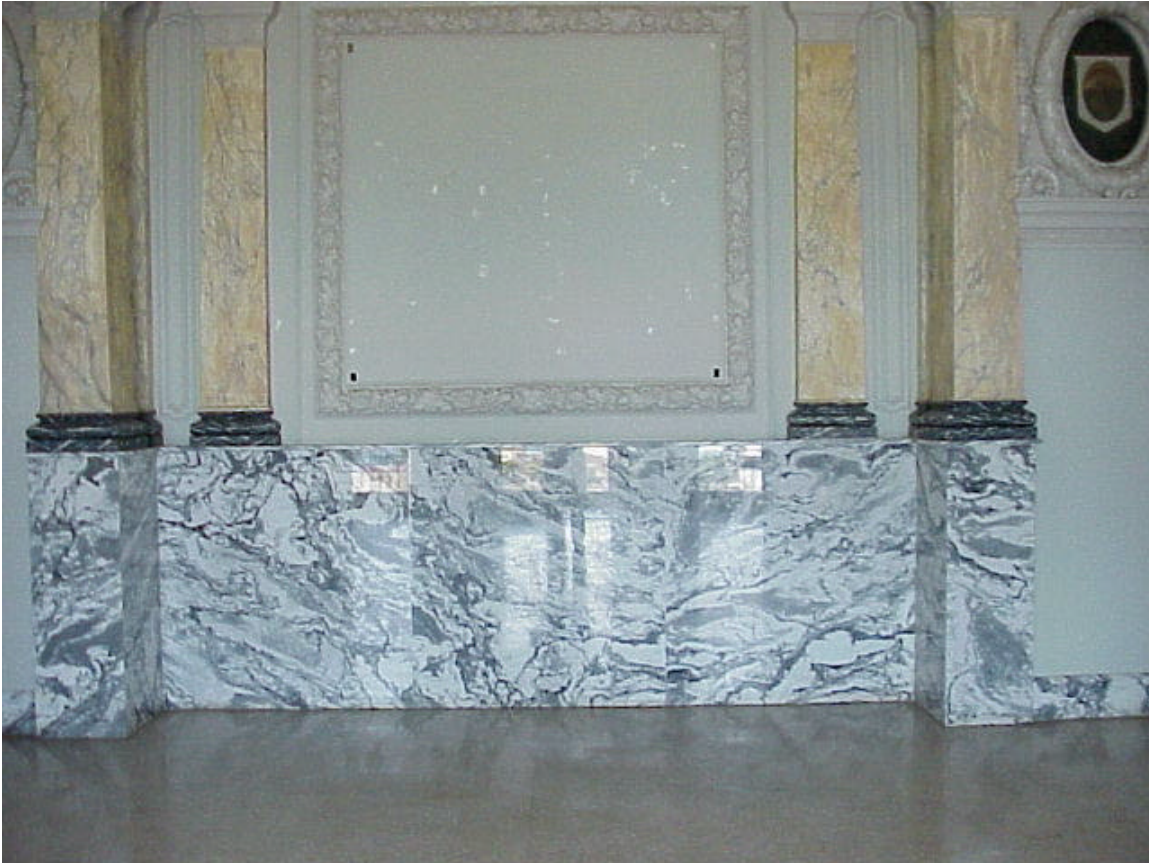
The interior of the casino was well maintained.

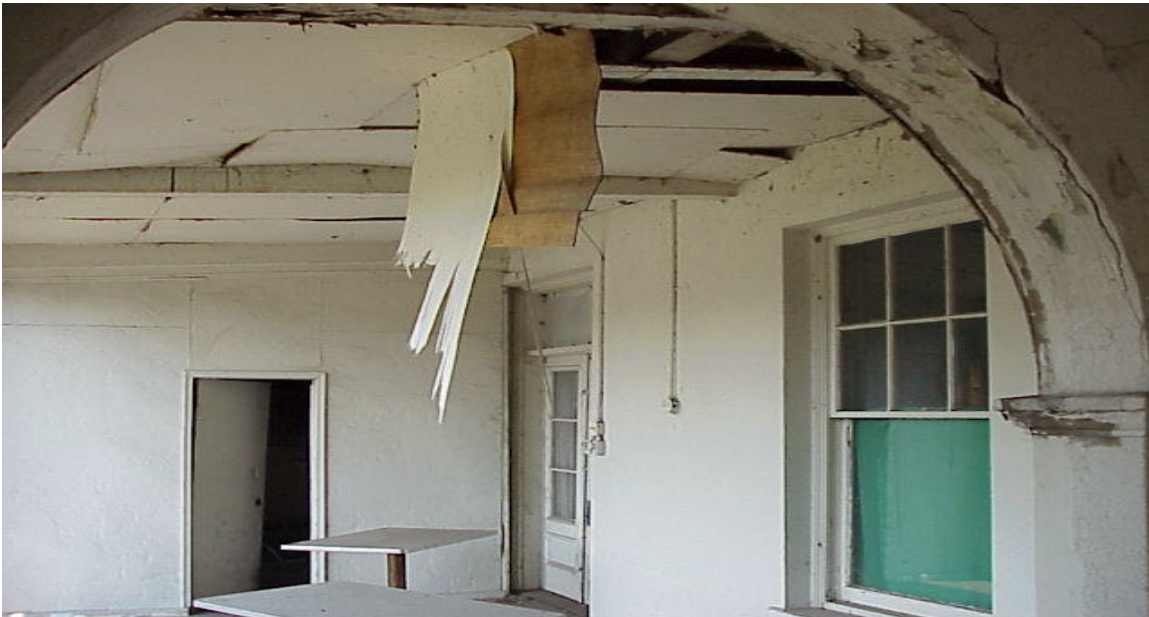
- Severe ceiling damage.
- Crumbling bricks.
- Peeling paint.
- Rusted wells.
- Pot holes in parking lot.

Severe ceiling and structure damage. Broken door and window.
